## Rudder column pearls from Philip Hubbell

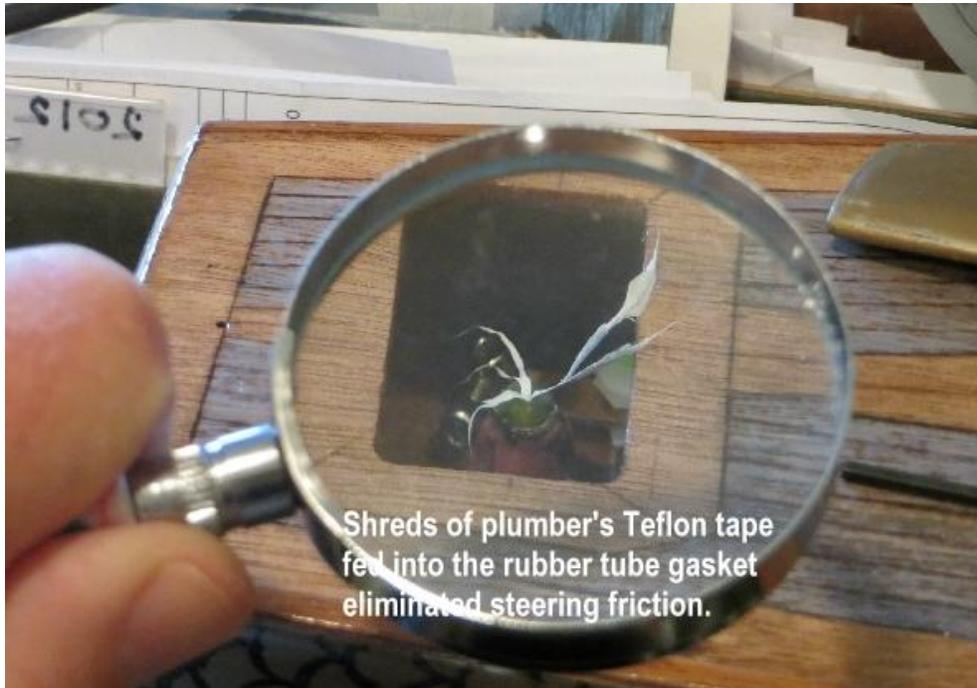
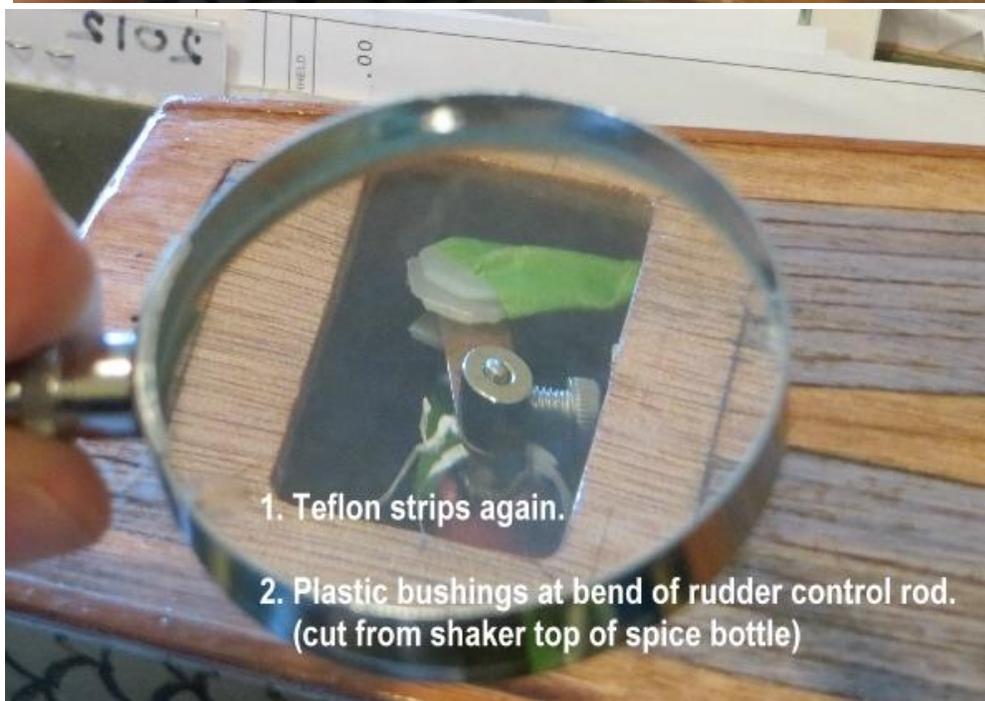
I experienced significant steering friction with the rubber tubing gasket atop the rudder column.

1. A few torn strips of Teflon tape fed into the column fixed it.
2. Lacking the suggested vise to sharpen the 90 degree bends in the rudder control rod, I added plastic bushings to raise the bend slightly from the hole in the rudder control arm and prevent jamming.
